4.1 GENERAL DESIGN CONSIDERATIONS

This chapter discusses structural, building envelope, and nonstructural building systems, and illustrates various types of wind-induced damage that affect them. It also presents six case studies. Numerous examples of best practices pertaining to new and existing hospitals are presented as recommended design guidelines. Incorporating those practices applicable to specific projects will result in greater wind-resistance reliability and will, therefore, decrease expenditures for repair of wind-damaged facilities, provide enhanced protection for occupants, and avoid disruption of critical services.

The recommendations presented in this manual are based on field observation research conducted on 25 hospitals that were struck by

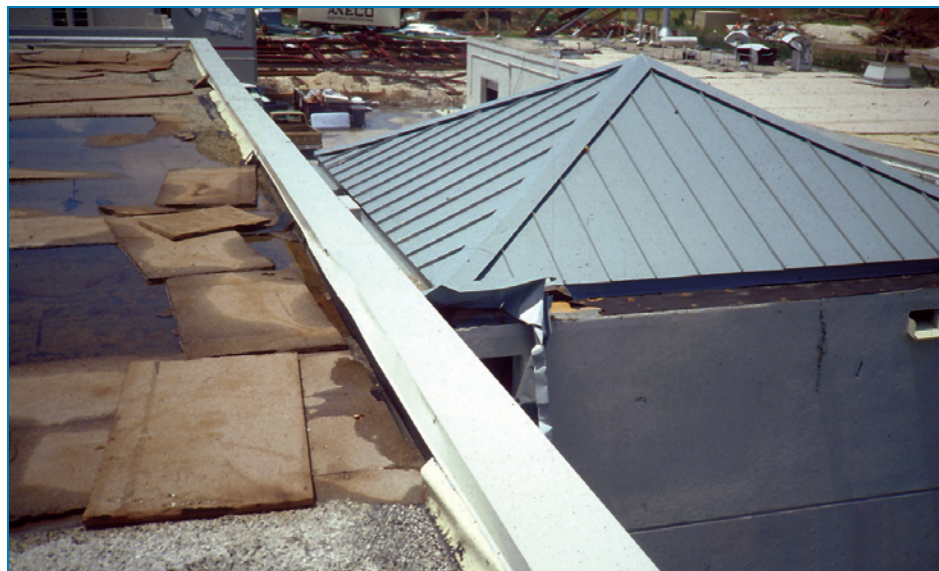
Figure 4-7:

Plan view of a portion of the building in Figure 4-6 showing the use of a corner uplift zone in lieu of a perimeter uplift zone on the low-slope roof in the vicinity of the stair tower

To avoid the roof membrane damage shown in Figure 4-6, it would be prudent to use corner uplift loads in lieu of perimeter uplift loads in the vicinity of the stair tower, as illustrated in Figure 4-7. Wind load increases due to building irregularities can be identified by wind tunnel studies; however, wind tunnel studies are rarely performed for hospitals. Therefore, identification of wind load increases due to building

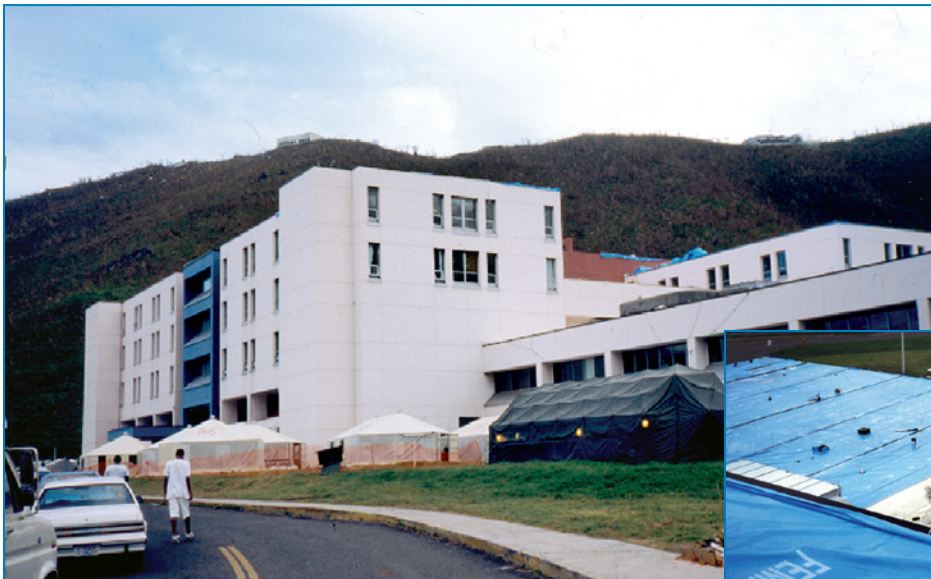
When damaged by wind, hospitals typically experience a variety of building component damage. For example, at the hospital shown in Figure 4-8, the roof covering was severely damaged, windows were broken, and rooftop equipment was blown away. The subsequent water infiltration required that most of the hospital be evacuated. The most common types of damage are discussed below in descending order of frequency.

Figure 4-8:
Field military hospital
in tents set up to
replace evacuated
hospital in U.S. Virgin
Islands following
Hurricane Marilyn
(1995)

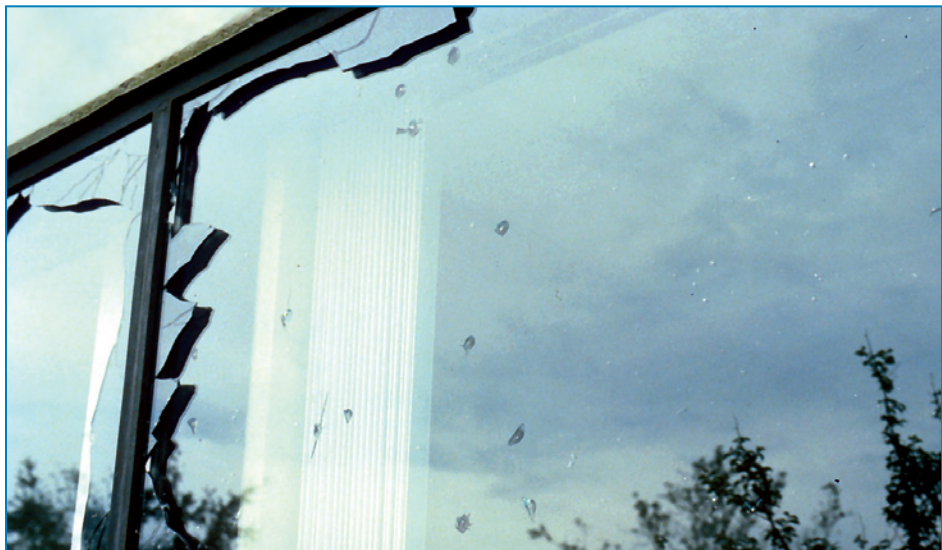
Glazing: Exterior glazing damage is very common during hurricanes and tornadoes, but is less common during other storms. The glass shown in Figure 4-10 was broken by the aggregate from a built-up roof. The inner panes had several impact craters. In several of the adjacent windows, both the outer and inner panes were broken. The aggregate flew more than 245 feet (the estimated wind speed was 104 mph, measured at 33 feet in Exposure C).

Figure 4-10:
The outer window
panes were broken by
aggregate from a built-
up roof. Hurricane
Hugo (South Carolina,
1989)

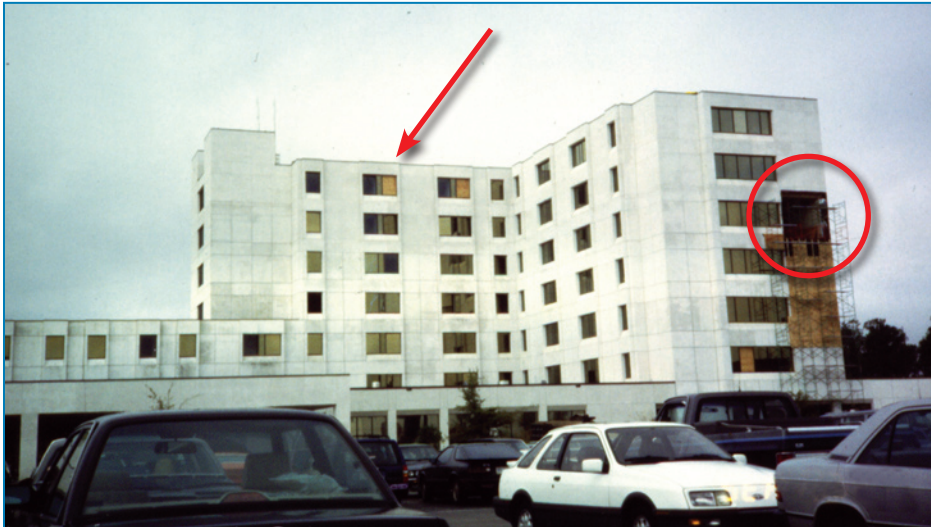
Wall collapse: Collapse of non-load-bearing exterior walls is common during hurricanes and tornadoes, but is less common during other storms. At the hospital shown in Figure 4-11, a portion of the non-load-bearing wall collapsed. Several windows were also broken by aggregate ballast blown from the hospital's roof (see Figure 4-5).

Figure 4-11:
Collapse of non-load-bearing wall (red circle) and broken glazing from roof aggregate (red arrow). Hurricane Hugo (South Carolina, 1989)

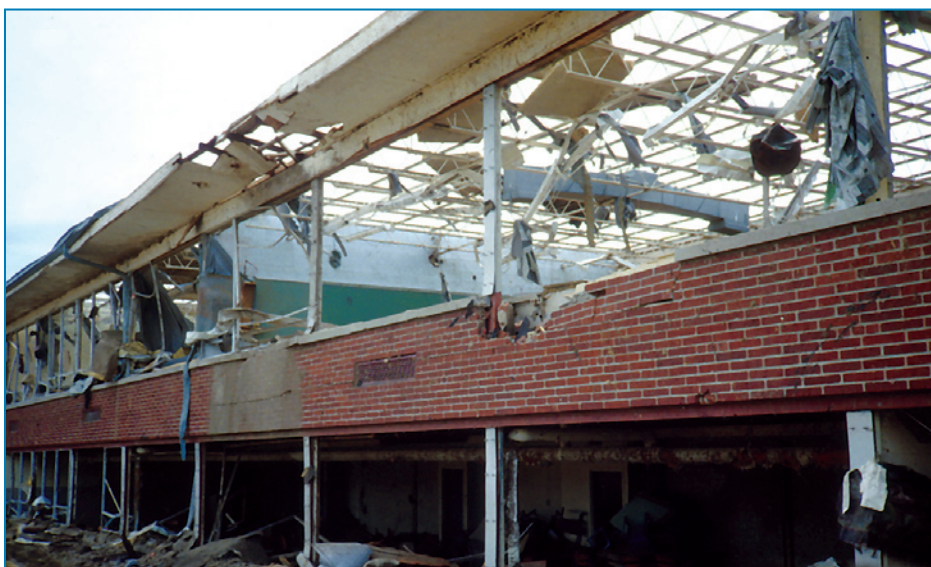
Structural system: Structural damage (e.g., roof deck blow-off, blow-off or collapse of the roof structure, collapse of exterior bearing walls, or collapse of the entire building or major portions thereof) is the principal type of damage that occurs during strong and violent tornadoes (see Figure 4-12)

Figure 4-12:
This building in Northern Illinois was heavily damaged by a strong tornado in 1990.

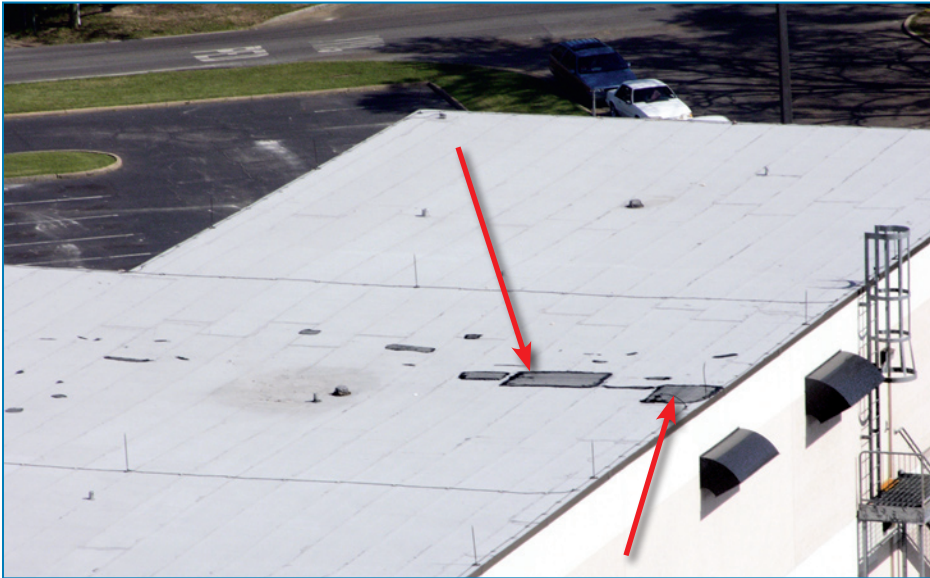
The West Florida Hospital (J on Figure 4-13) and several of the other buildings on the campus experienced a variety of damages during the storm. The roof membrane was punctured in several places by windborne missiles and by damaged rooftop equipment (see Figures 4-14 to 4-16).

Figure 4-14:
Numerous repairs where the modified bitumen roof membrane was punctured by missiles. Water from the punctured membrane entered the surgical suite.

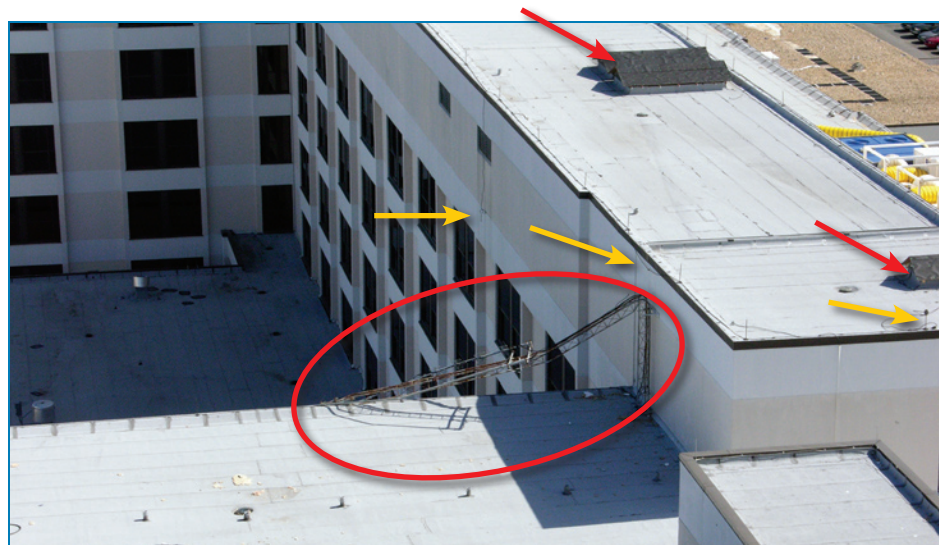
Figure 4-16:
 Damaged rooftop equipment. Although some of this damage may have been caused by wind pressure, some of it was caused by missiles. Note the open ducts (red arrows).

Ductwork: To avoid wind and wind-borne debris damage to rooftop ductwork, it is recommended that ductwork not be installed on the roof (see Figures 4-16, 4-60, and 4-124). If ductwork is installed on the roof, it is recommended that the ducts' gauge and the method of attachment be able to resist the design wind loads.

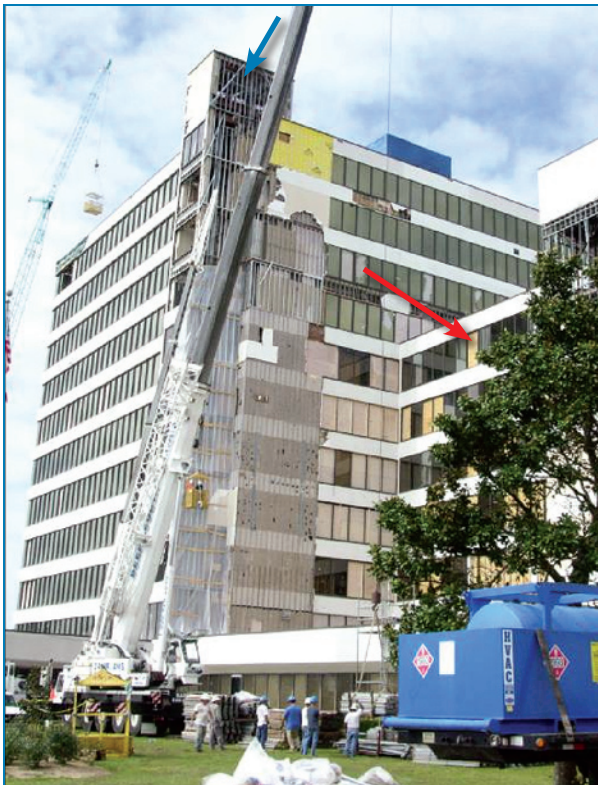
Figure 4-18:

With loss of the EIFS wall covering, wind-driven rain destroyed the elevator control equipment (see Figure 4-22). Water damage to the elevator control equipment resulted in failure of the MOB stair tower elevator. As a result, several people were trapped in the MOB stair tower elevator shown in Figure 4-18 during the hurricane. Fortunately, the MOB had another bank of elevators in the core of the building that was not damaged, so vertical transportation was still possible, although handicapped by the loss of the stair tower elevator. At the MOB stair tower, some of the gypsum board on the interior side of the studs collapsed into the stairway, thus trapping a maintenance worker who had gone to the mechanical penthouse during the hurricane.

Broken windows in the connecting walkway between the hospital (right) and MOB (left) (red arrow). Also note the broken windows and loss of EIFS (including the gypsum board on both sides of the studs) at the elevator enclosure (blue arrow).

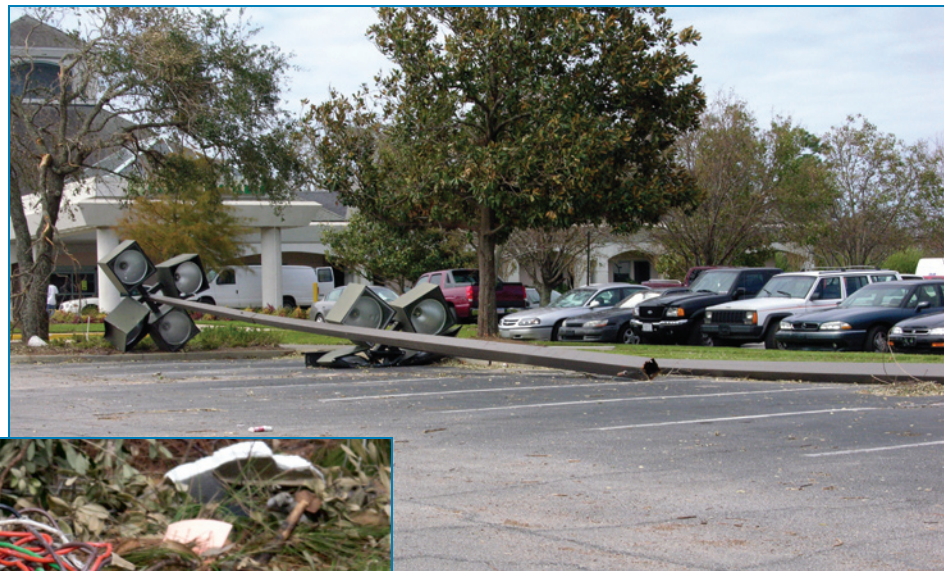
Figure 4-21:

At the imaging center (F on Figure 4-13), there were some broken windows and a fan cowling blew away. Some large parking lot light fixtures also collapsed because the bottoms of the tubes were severely corroded (Figure 4-21).

Collapsed light fixtures caused by severe corrosion (see inset). The cancer treatment facility is beyond to the left.

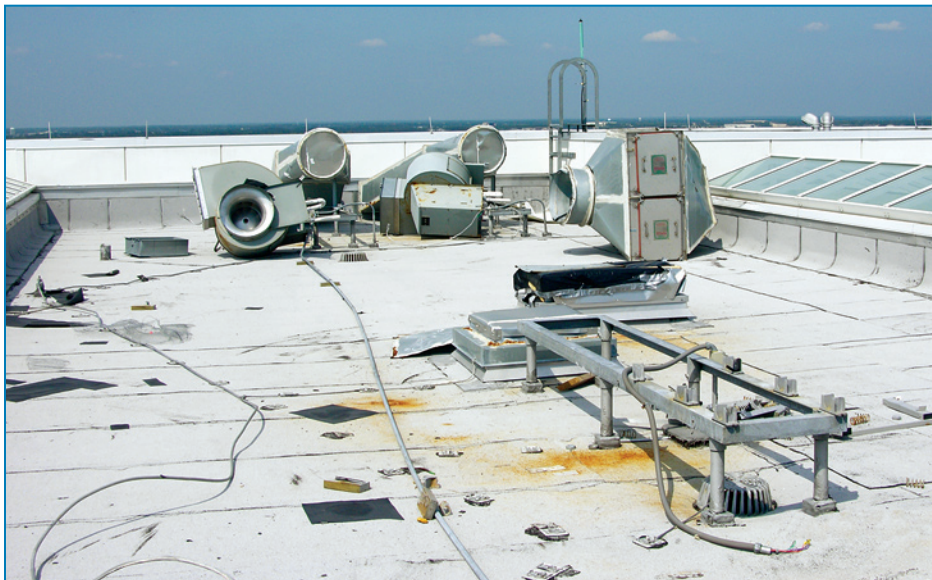
Figure 4-25:
Temporary coverings placed over two large openings in the roof that were left after the ductwork blew away. Hurricane Katrina (Mississippi, 2005)

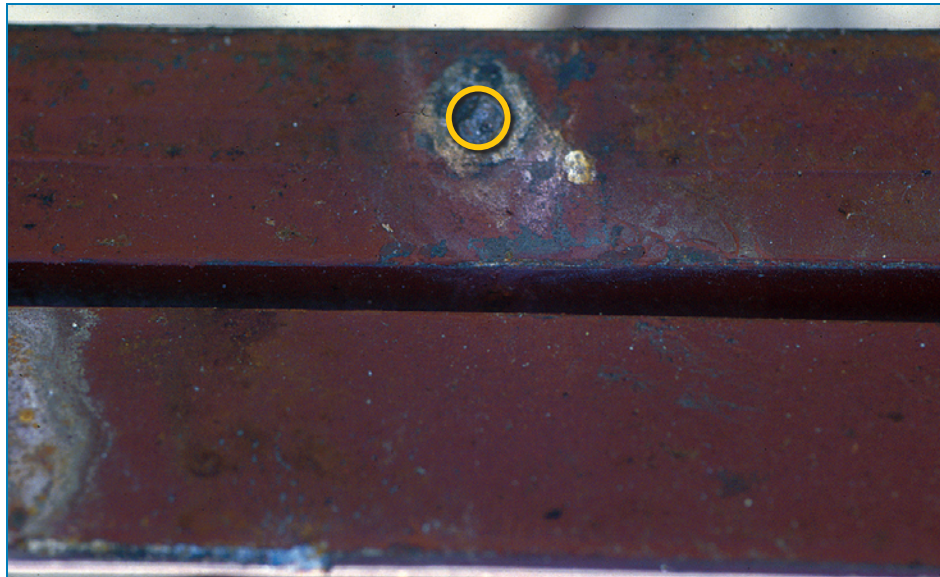
Figure 4-28:

- For roof decks, concrete, steel, plywood, or oriented strand board (OSB) is recommended.
- For steel roof decks, it is recommended that a screw attachment be specified, rather than puddle welds or powder-driven pins. Screws are more reliable and much less susceptible to workmanship problems. Figure 4-28 shows decking that was attached with puddle welds. At most of the welds, there was only superficial bonding of the metal deck to the joist, as illustrated by this example. Only a small portion of the deck near the center of the weld area (as delineated by the circle) was well fused to the joist. Figures 4-29 and 4-30 show problems with acoustical decking attached with powder-driven pins. The pin shown on the left of Figure 4-30 is properly seated. However, the pin at the right did not penetrate far enough into the steel joist below.

View looking down at the top of a steel joist after the metal decking blew away. Only a small portion of the deck was well fused to the joist (circled area). Tornado (Oklahoma, 1999)

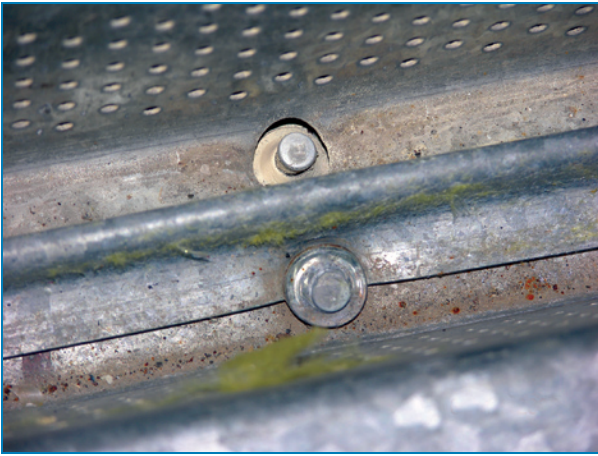
Figure 4-29:

Looking down at a sidelap of a deck attached with powder-driven pins. The washer at the top pin blew through the deck.

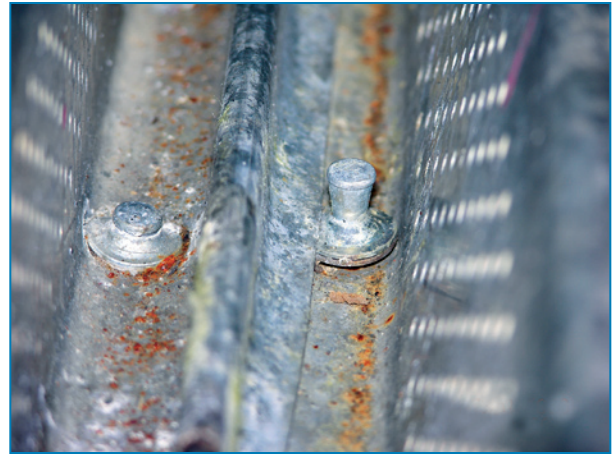
Figure 4-30:

View looking along a sidelap of a deck attached with powder-driven pins. The right pin does not provide adequate uplift and shear resistance.

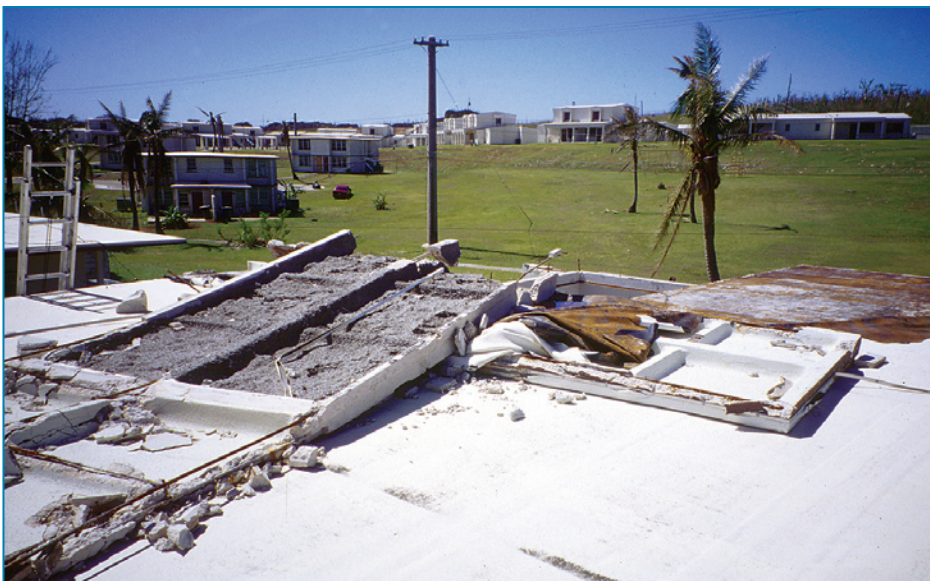
Figure 4-31:

- For attaching wood-sheathed roof decks, screws, ring-shank, or screw-shank nails are recommended in the corner regions of the roof. Where the basic wind speed is greater than 90 mph, these types of fasteners are also recommended for the perimeter regions of the roof.
- For precast concrete decks it is recommended that the deck connections be designed to resist the design uplift loads because the deck dead load itself is often insufficient to resist the uplift. The deck in Figure 4-31 had bolts to provide uplift resistance; however, anchor plates and nuts had not been installed. Without the anchor plates, the dead load of the deck was insufficient to resist the wind uplift load.

Portions of this waffled precast concrete roof deck were blown off. Typhoon Paka (Guam, 1997)

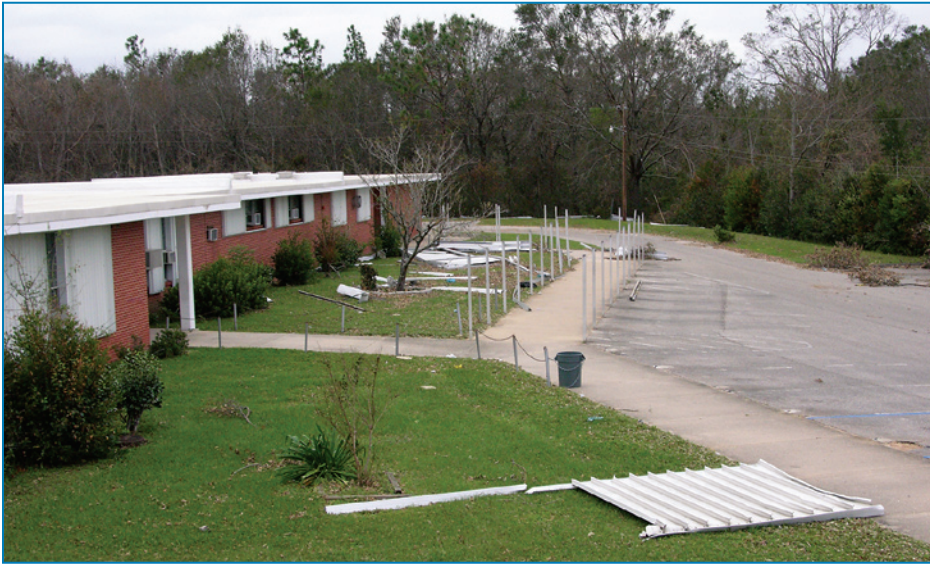
Figure 4-33:
The destroyed walkway canopy in front of this building became wind-borne debris. Hurricane Ivan (Florida, 2004)

- Walkway and entrance canopies are often damaged during high winds (see Figure 4-33). Wind-borne debris from damaged canopies can damage nearby buildings and injure people, hence these elements should also receive design and construction attention.

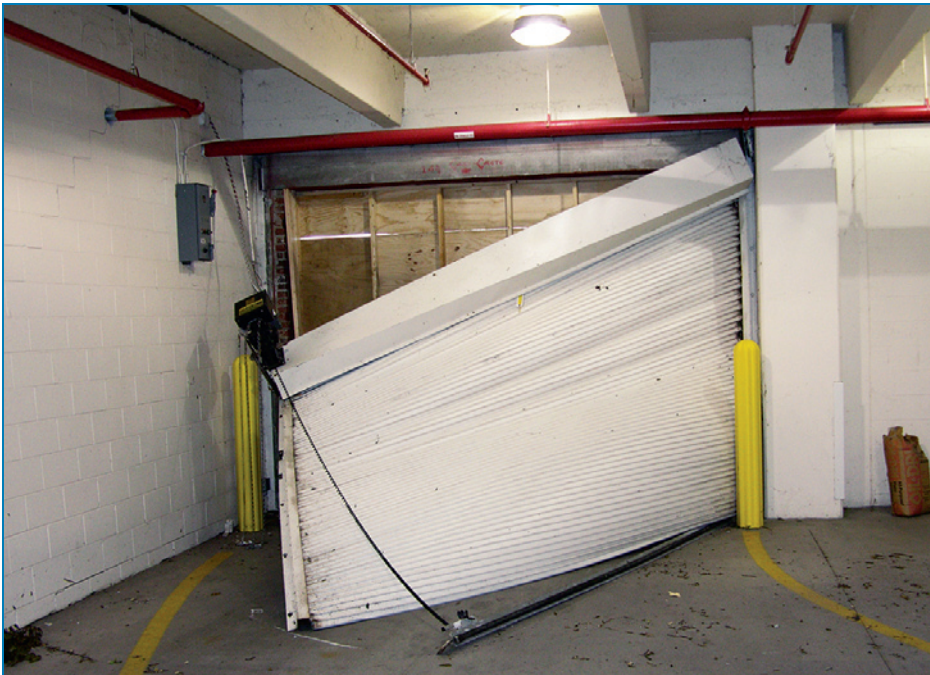
Figure 4-35:

insufficient wind resistance, or by inadequate attachment of the tracks or nailers to the wall (see Figure 4-35).

This new rolling door failed because the CMU spalled at the door frame's expansion bolts, which were too close to the end of the CMU. Hurricane Charley (Florida, 2004)

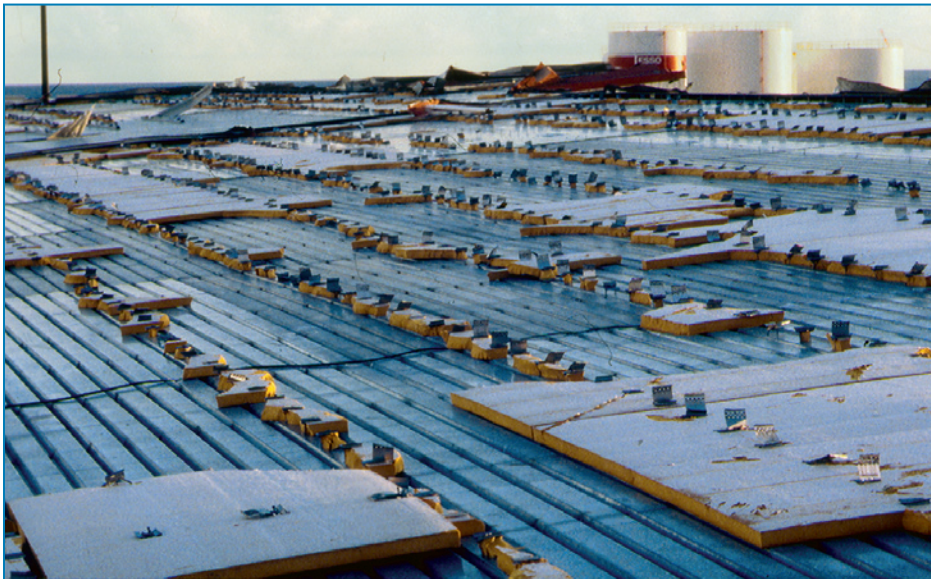
If the metal panels are blown off or punctured during a hurricane, the secondary membrane should provide watertight protection unless the roof is hit with missiles of very high momentum. At the roof shown in Figure 4-73, the structural standing seam panel clips bore on rigid insulation over a steel deck. Had a secondary membrane been installed over the steel deck, the membrane would have likely prevented significant interior water damage and facility disruption.

Figure 4-73:
Significant interior water damage and facility interruption occurred after the standing seam roof blew off. Hurricane Marilyn (U.S. Virgin Islands, 1995)

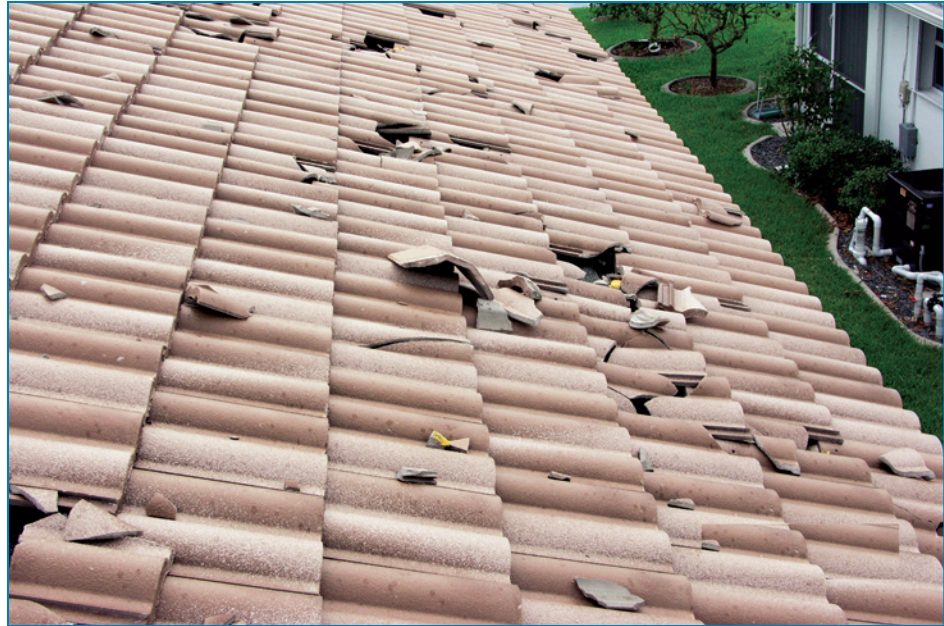
Figure 4-74:
Brittle roof coverings, like slate and tile, can be broken by missiles, and tile debris can break other tiles. Hurricane Charley (Florida, 2004)

In order to avoid the possibility of roofing components blowing off and striking people arriving at a hospital during a storm, the following roof systems are not recommended: aggregate surfacings, either on BUR, single-ply or SPF; lightweight concrete pavers; cementitious-coated insulation boards; slate; and tile (see Figure 4-74). Even when slates and tiles are properly attached to resist wind loads, their brittleness makes them vulnerable to breakage as a result of wind-borne debris impact. The tile and slate fragments can be blown off the roof, and fragments can damage other parts of the roof, causing a cascading failure.

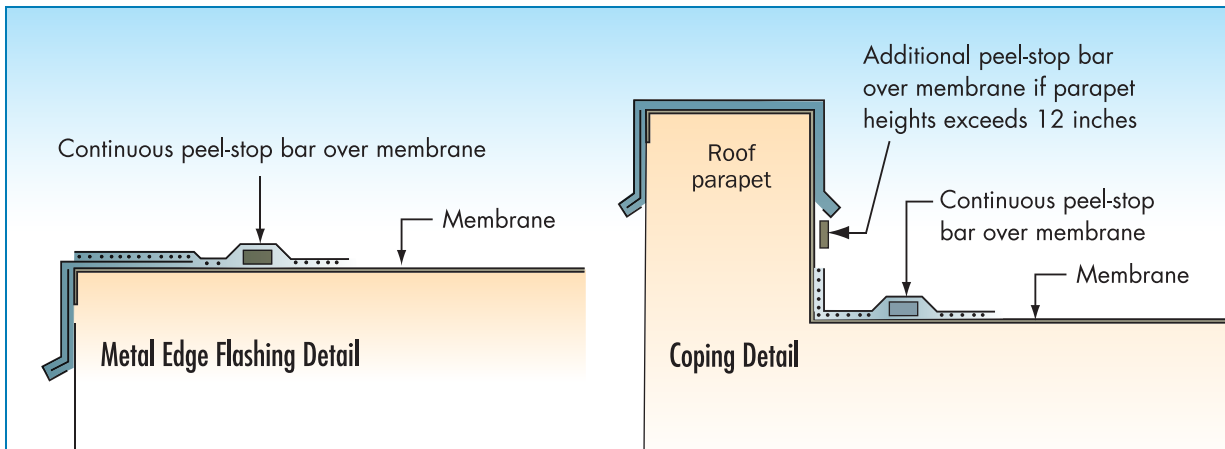
Figure 4-77:

A continuous peel-stop bar over the membrane may prevent a catastrophic progressive failure if the edge flashing or coping is blown off. (Modified from FEMA 55, 2000)

Edge flashings and copings: If cleats are used for attachment, it is recommended that a “peel-stop” bar be placed over the roof membrane near the edge flashing/coping, as illustrated in Figure 4-77. The purpose of the bar is to provide secondary protection against membrane lifting and peeling in the event that edge flashing/coping fails. A robust bar specifically made for bar-over mechanically attached single-ply systems is recommended. The bar needs to be very well anchored to the parapet or the deck. Depending on design wind loads, spacing between 4 and 12 inches on center is recommended. A gap of a few inches should be left between each bar to allow for water flow across the membrane. After the bar is attached, it is stripped over with a stripping ply.

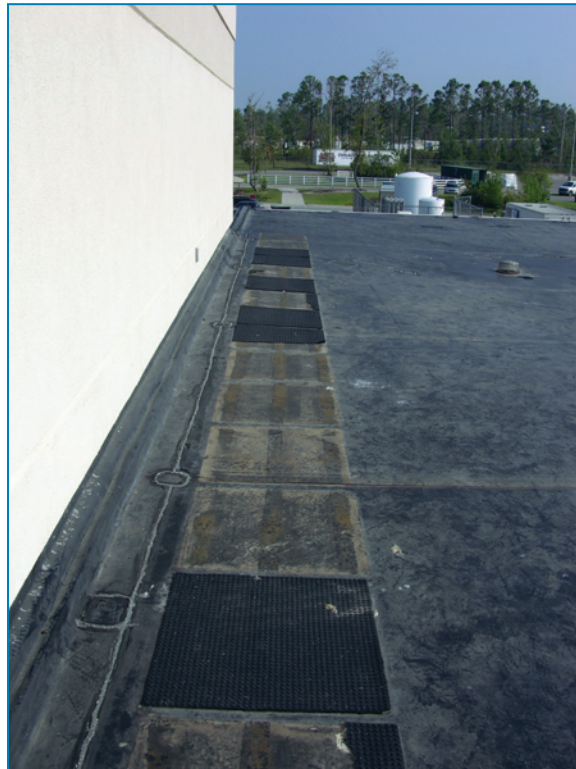
Figure 4-78:

Several rubber walkway pads were blown off the single-ply membrane roof on this hospital. Hurricane Katrina (Mississippi, 2005)

Walkway pads: Roof walkway pads are frequently blown off during hurricanes (Figures 4-78 and 4-82). Pad blow-off does not usually damage the roof membrane. However, wind-borne pad debris can damage other building components and injure people. Currently there is no test standard to evaluate uplift resistance of walkway pads. Walkway pads are therefore not recommended in hurricane-prone regions.

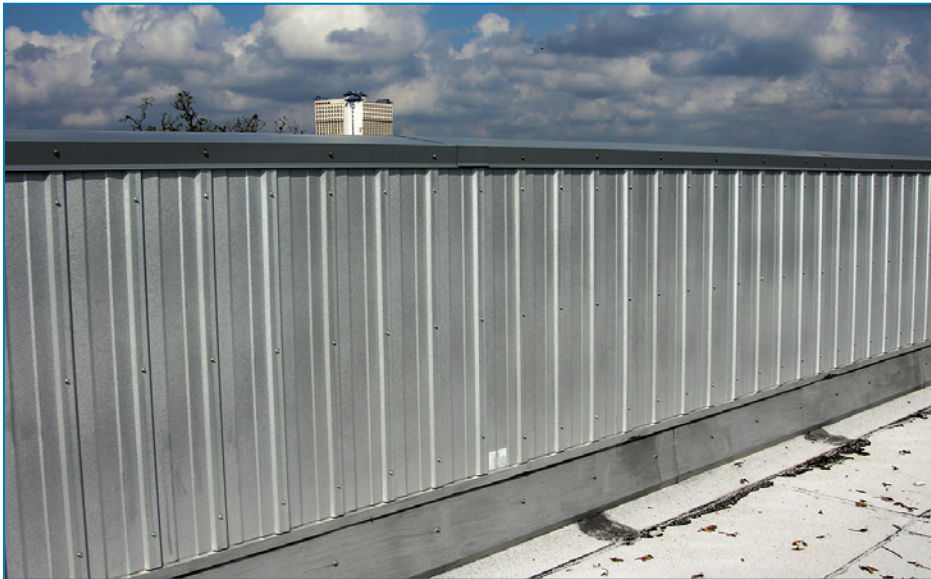
Figure 4-79:
Base flashing
protected by metal
panels attached with
exposed screws.
Hurricane Katrina
(Mississippi, 2005)

- For a PMR, it is recommended that pavers weighing a minimum of 22 psf be specified. In addition, base flashings should be protected with metal (such as shown in Figure 4-79) to provide debris protection. Parapets with a 3-foot minimum height (or higher if so indicated by ANSI/SPRI RP-4, 2002) are recommended at roof edges. This manual recommends that PMRs not be used for hospitals in hurricane-prone regions where the basic wind speed exceeds 130 mph.

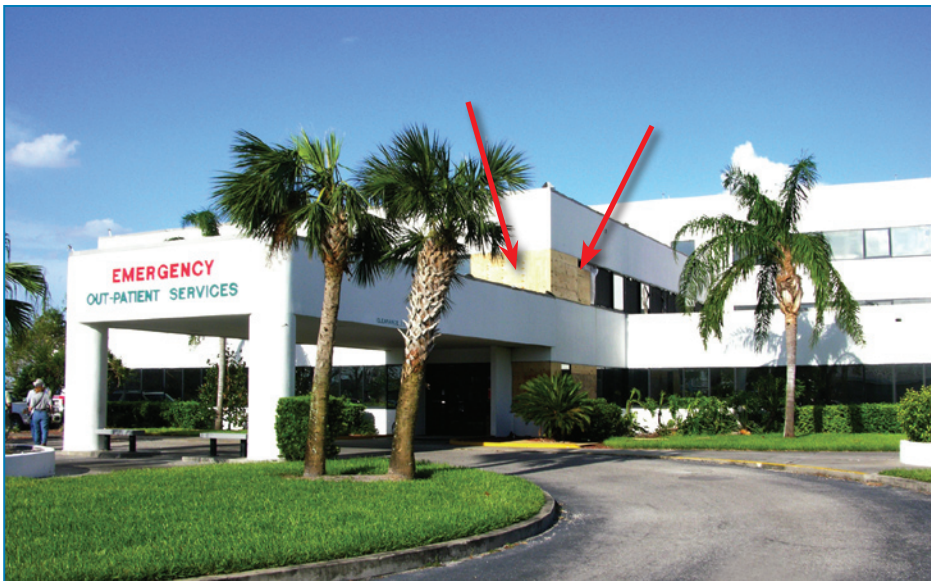
The hospital sustained damage to windows, rooftop equipment, and a freestanding storage building on the campus. Thirty-three windows were broken, including patient room windows and windows at three of the eight ICU rooms (Figures 4-80 and 4-81). Windows were also broken in many vehicles in the parking lot. The majority of the glass breakage was caused by aggregate blown from the hospital built-up roofs. Some of the glass breakage may have been due to blown-off gutters and walkway pads from the hospital's roof (Figure 4-82) or other missiles such as tree limbs; blown off gutters can be high-momentum missiles that can travel a substantial distance (see Figure 4-81).

Figure 4-80:
The second floor beyond the canopy houses the ICU. Several windows along the two ICU walls that are visible were broken.

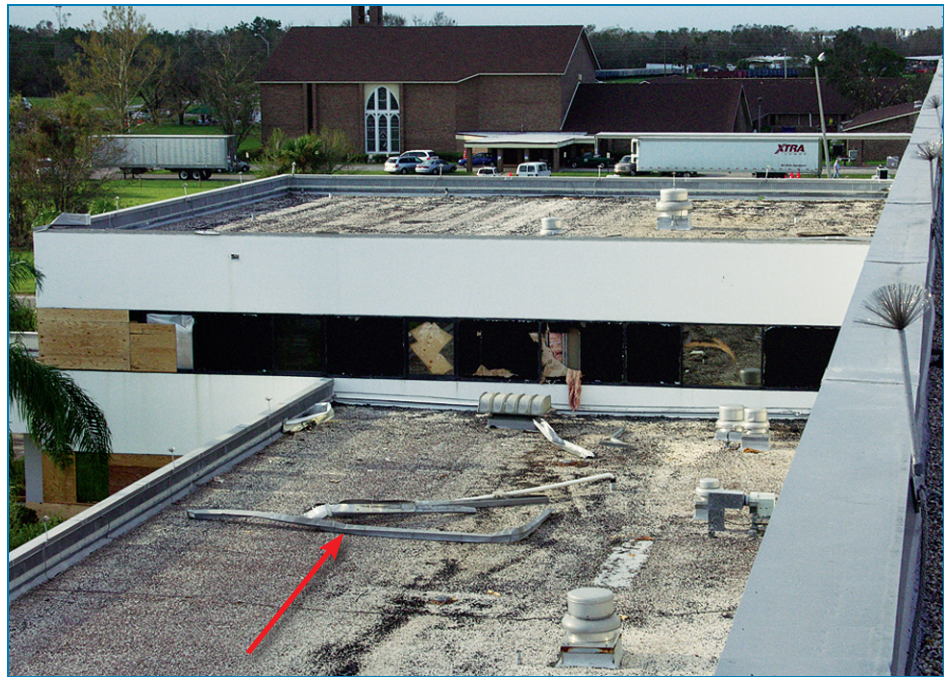
Figure 4-81:

A view of the ICU from the third floor roof. The gutters (red arrow) are from the back side of the third floor roof.

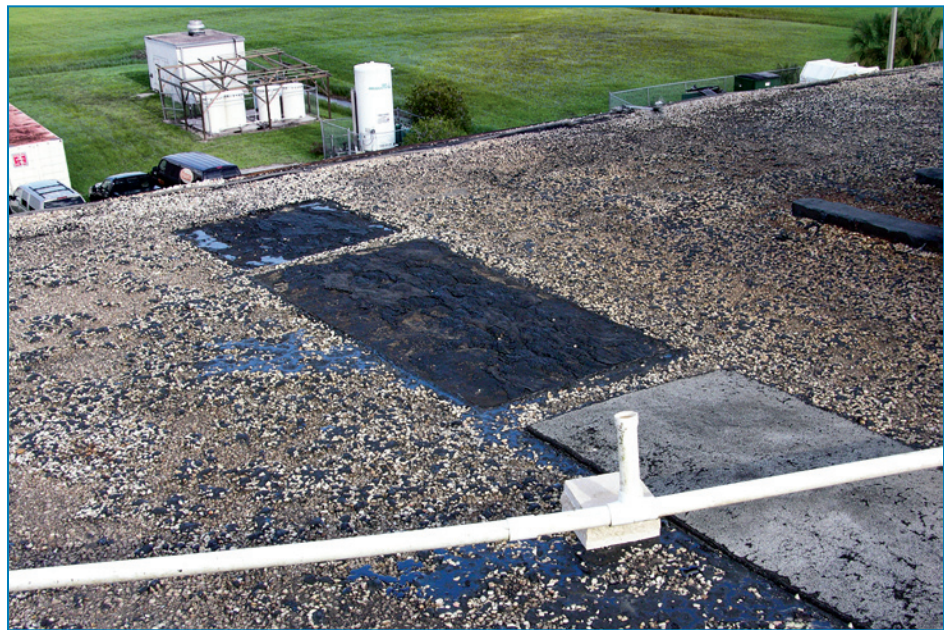
Figure 4-82:

View of the back side of the third floor roof where the gutter and an asphalt plank walkway pad were blown away. The loose aggregate surfacing was also blown away.

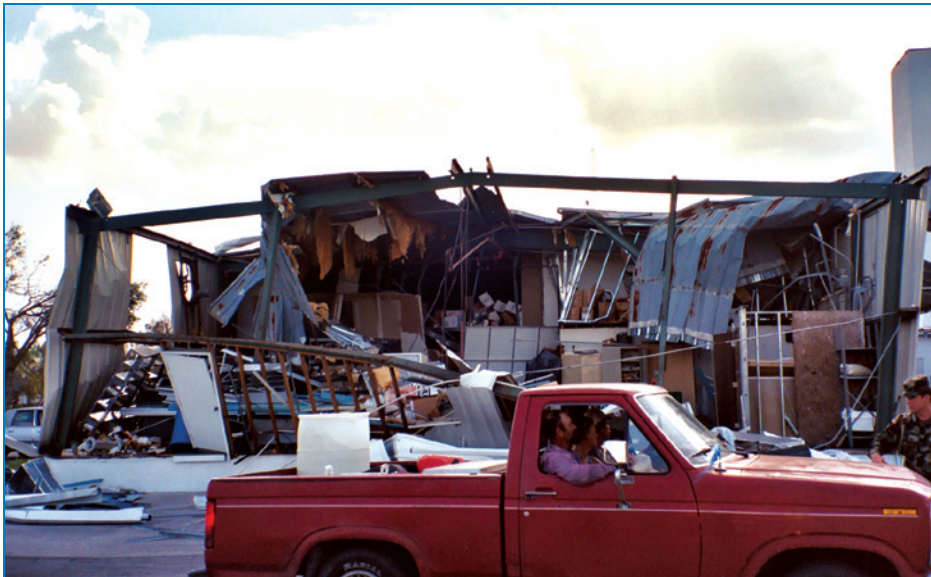
The metal storage building that contained the hospital's supplies, maintenance shop, environmental services, and shipping and receiving collapsed, and its loss was significant for the hospital operations. Almost all of the tools and stock materials for repairs were lost (Figure 4-84). Tents were set up after the hurricane to provide storage. Because of subsequent storms in the next several weeks (including two hurricanes), the stored items had to be moved in and out of the tents on several occasions.

Figure 4-84:
This pre-engineered storage building contained the hospital supplies and maintenance shop.

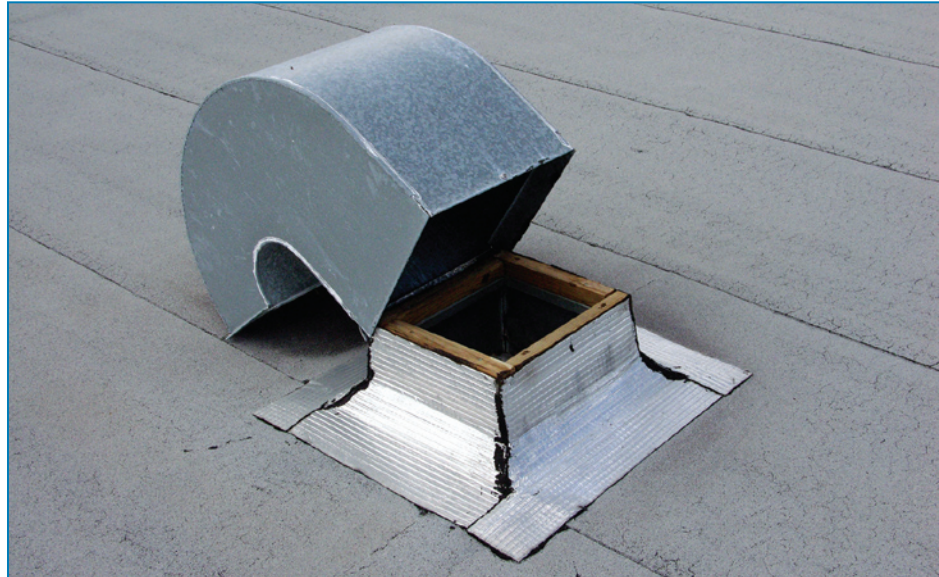
Figure 4-85:

enter the facility where equipment was displaced (see Figure 4-85). The most common problems typically relate to inadequate equipment anchorage, inadequate strength of the equipment itself, and corrosion.

This gooseneck was attached with only two small screws. A substantial amount of water was able to enter the building during Hurricane Francis. (Florida, 2004)

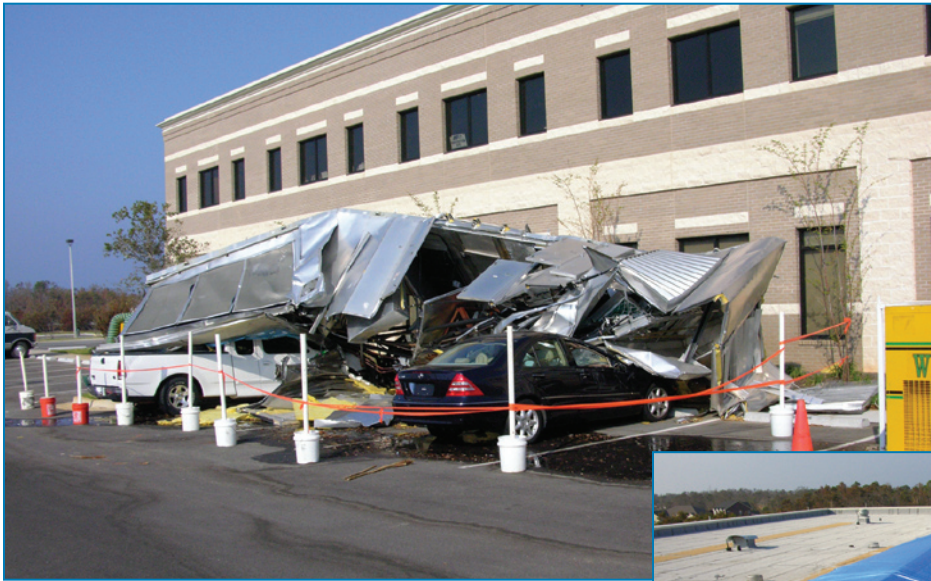
to resist the design wind load. The 30' x 10' x 8' 18,000-pound HVAC unit shown in Figure 4-86 was attached to its curb with 16 straps (one screw per strap). Although the wind speeds were estimated to be only 85 to 95 miles per hour (peak gust), the HVAC unit blew off the medical office building. The inset at Figure 4-86 shows the curb upon which the unit was attached. A substantial amount of water entered the building at the curb openings before the temporary tarp was placed.

Figure 4-86: Although this 18,000-pound HVAC unit was attached to its curb with 16 straps, it blew off during Hurricane Ivan. (Florida, 2004)

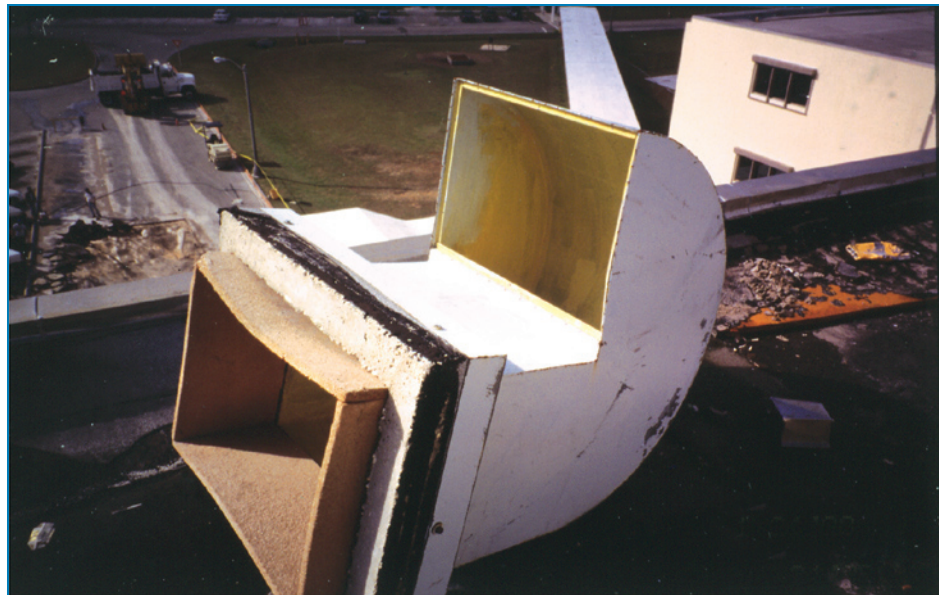
Figure 4-87:

To anchor fans, small HVAC units, and relief air hoods, the minimum attachment schedule provided in Table 4-1 is recommended. The attachment of the curb to the roof deck also needs to be designed and constructed to resist the design loads. The cast-in-place concrete curb shown in Figure 4-87 was cold-cast over a concrete roof deck. Dowels were not installed between the deck and the curb, hence a weak connection occurred.

The gooseneck on this hospital remained attached to the curb, but the curb detached from the deck. Typhoon Paka (Guam, 1997)

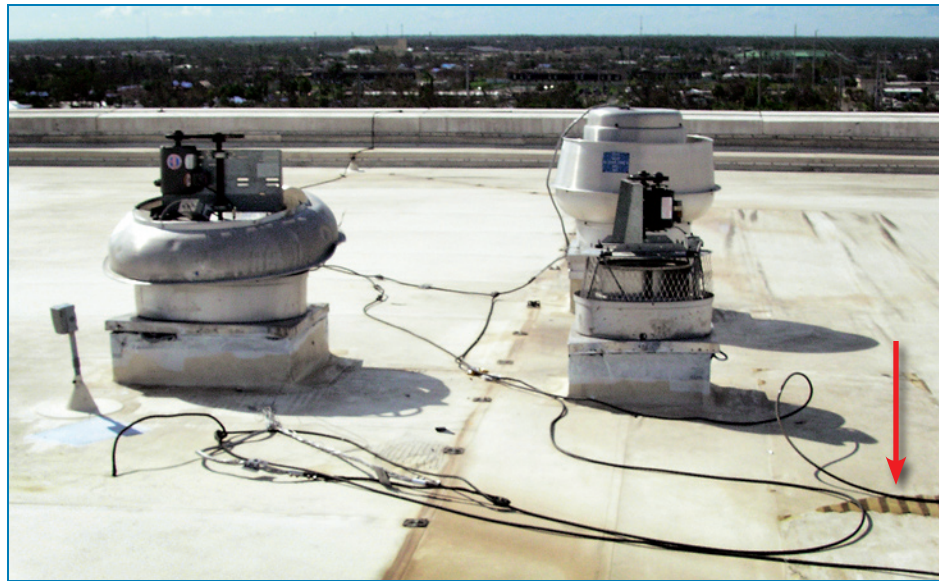
Figure 4-88:

Cowlings blew off two of the three fans. Note also the loose lightning protection system conductors and missing walkway pad (red arrow). Hurricane Charley (Florida, 2004)

Fan cowling attachment: Fans are frequently blown off their curbs because they are poorly attached. When fans are well attached, the cowlings frequently blow off (see Figure 4-88). Blown off cowlings can tear roof membranes and break glazing. Unless the fan manufacturer specifically engineered the cowling attachment to resist the design wind load, cable tie-downs (see Figure 4-89) are recommended to avoid cowling blow-off. For fan cowlings less than 4 feet in diameter, $\frac{1}{2}$ -inch diameter stainless steel cables are recommended. For larger cowlings, use $\frac{3}{16}$ -inch diameter cables. When the basic wind speed is 120 mph or less, specify two cables. Where the basic wind speed is greater than 120 mph, specify four cables. To minimize leakage potential at the anchor point, it is recommended that the cables be adequately anchored to the equipment curb (rather than anchored to the roof deck). The attachment of the curb itself also needs to be designed and specified.

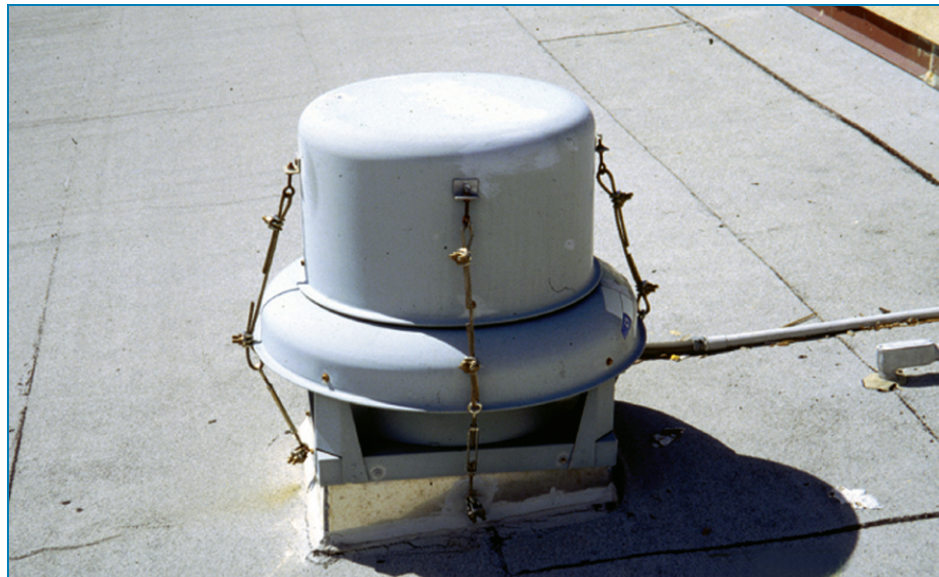
Figure 4-89:

Cables were attached to prevent the cowling from blowing off. Typhoon Paka (Guam, 1997)

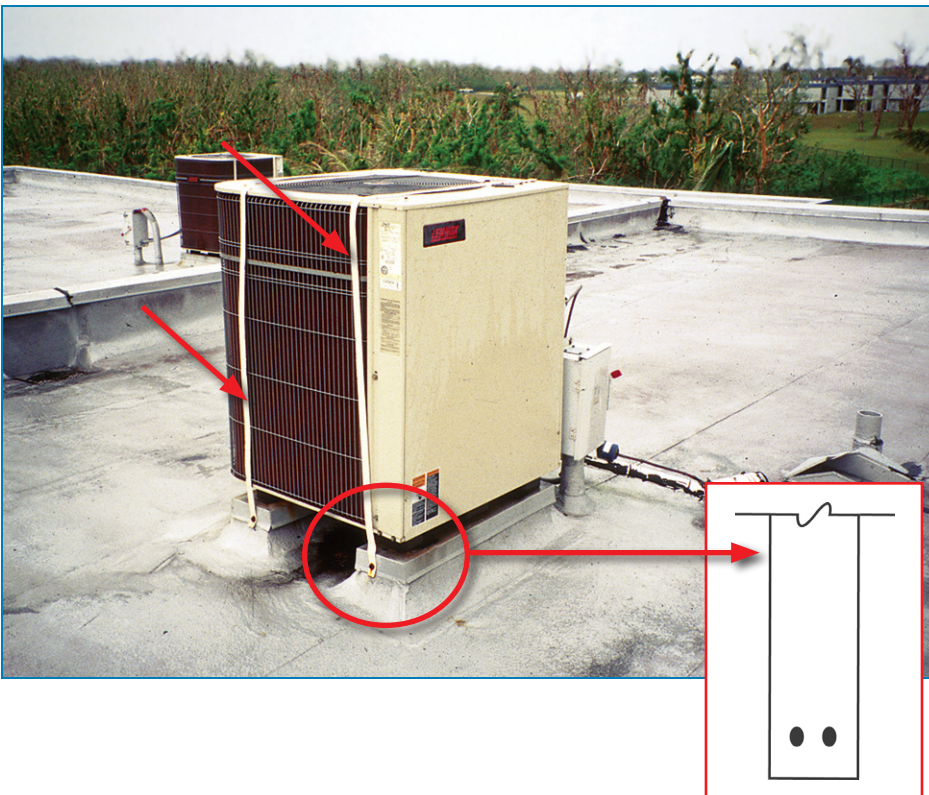
Figure 4-91:
This condenser
had supplemental
attachment straps (see
red arrows). Typhoon
Paka (Guam, 1997)

metal straps with two side-by-side #12 screws or bolts with proper end and edge distances at each strap end are recommended when the basic wind speed is greater than 90 mph (see Figure 4-91).

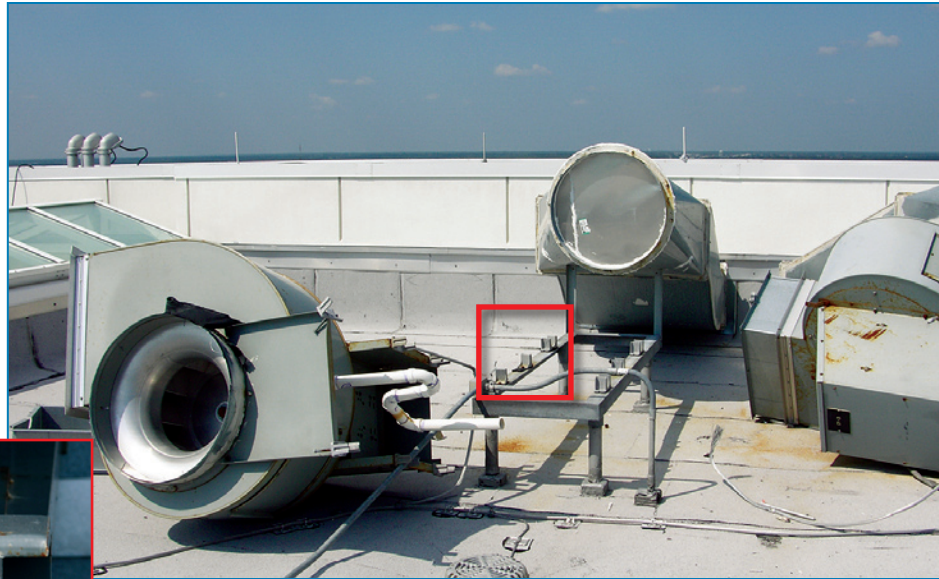
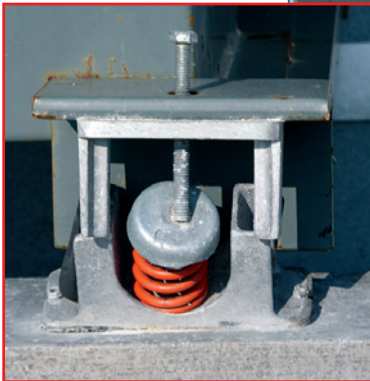
Figure 4-92:
Failure of vibration isolators that provided lateral resistance but no uplift resistance caused equipment damage. A damaged vibration isolator is shown in the inset. Hurricane Katrina (Mississippi, 2005)

Vibration isolators: If vibration isolators are used to mount equipment, only those able to resist design uplift loads should be specified and installed, or an alternative means to accommodate uplift resistance should be provided (see Figure 4-92).

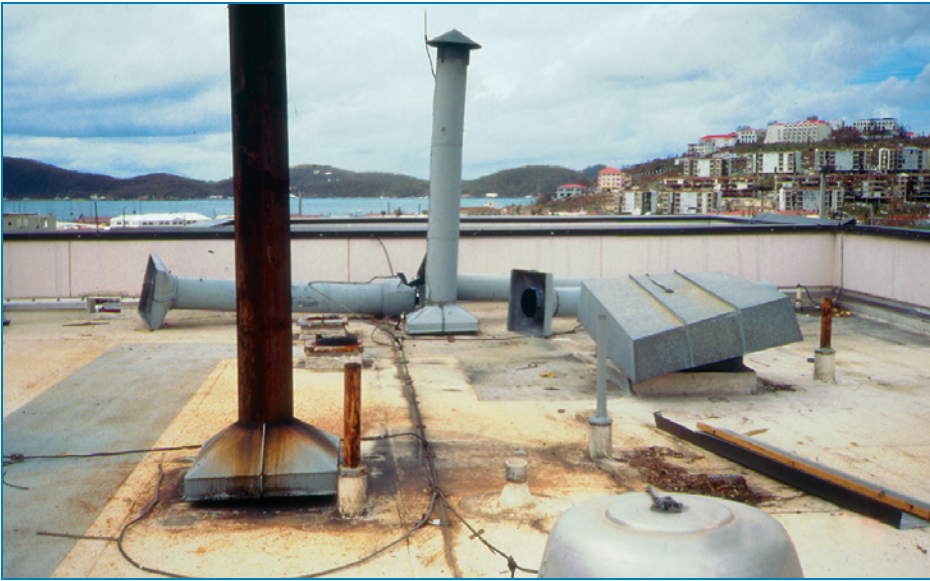
Figure 4-93:
Three of the five stacks that did not have guy-wires were blown down. Hurricane Marilyn (U.S. Virgin Islands, 1995)

Boiler and exhaust stack attachment: To avoid wind damage to boiler and exhaust stacks, wind loads on stacks should be calculated and guy-wires should be designed and constructed to resist the loads. Toppled stacks, as shown at the hospital in Figure 4-93, can allow water to enter the building at the stack penetration, damage the roof membrane, and become wind-borne debris. The designer should advise the building owner that guy-wires should be inspected annually to ensure they are taut.
